Evaluating metallic artefact of biodegradable magnesium-based implants in magnetic resonance imaging

ABSTRACT

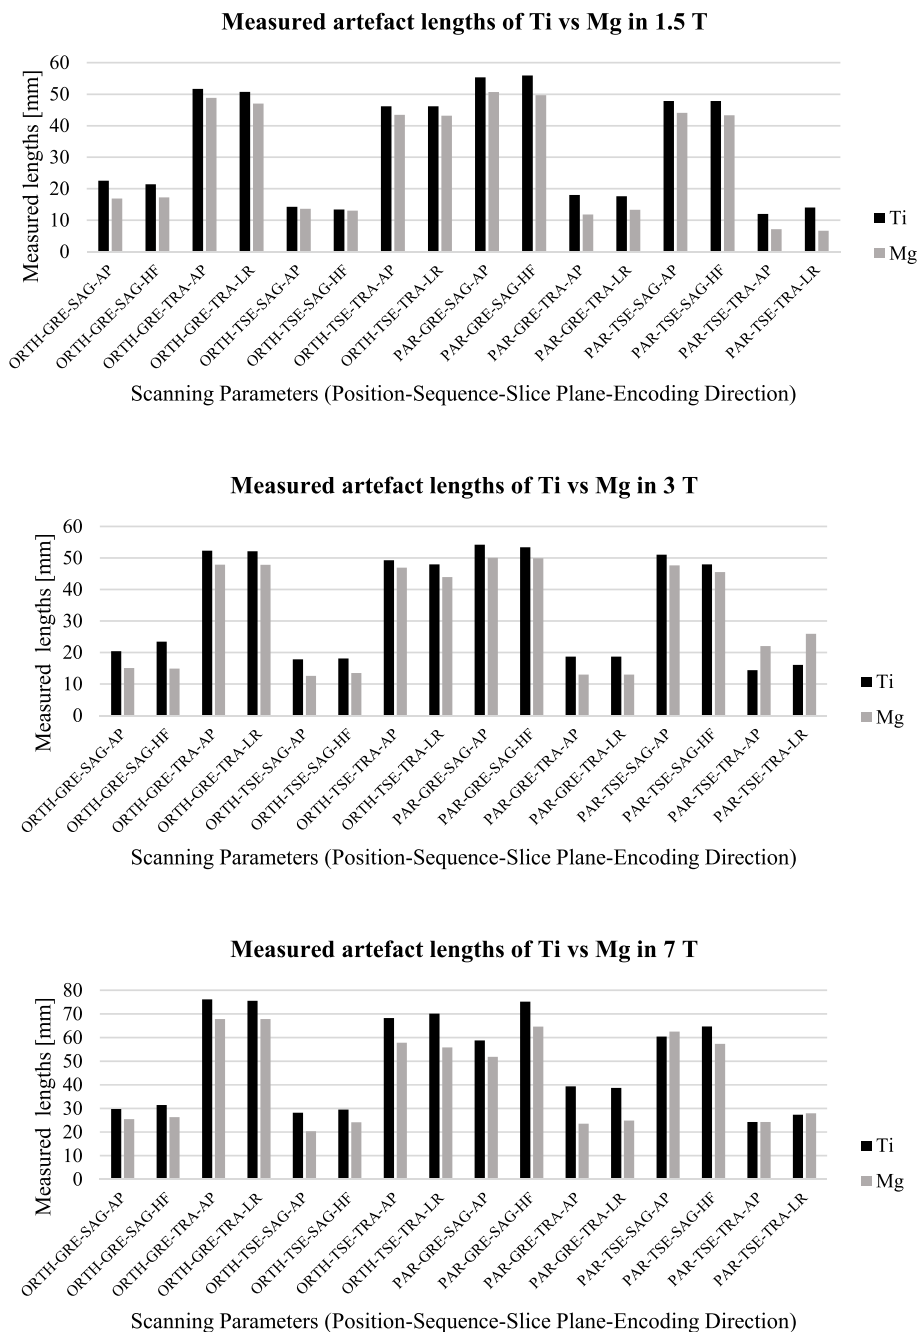
Fig. 3. Measured artefact lengths of Ti and Mg in various magnetic strengths. Implant position relative to the main magnetic field, sequence applied, slice plane, and phase encoding direction were altered for artefact measurements. (Reading format of y-axis: IMPLANT POSITION-SEQUENCE-SLICE PLANE-ENCODING DIRECTION).

By varying different MRI scanning parameters (seen in Fig. 3) the significant differences were found for the Ti and Mg samples. For all main field magnetic strengths, the Mg-samples produced significantly less artefacts than the Ti counterparts. Turbo spin echo sequences produced lower artefacts versus gradient echo sequence. The averaged diameter- and length-measured artefacts are summarised in Table 4. Averaged distortions or artefact measured based on material and magnetic field strength are documented in Fig. 4. An increase in magnetic field strength results in an increase in artefact size for both materials. The application of the gradient echo sequence and use of Ti material generally produced higher distortions than the turbo spin echo sequence and the use of Mg with the exception of the PAR-TSE-TRA-AP/LR protocol at 3.0 T and 7.0 T of the PAR-TSE-SAG-AP protocol at 7.0 T. The Tukey post-hoc test revealed significant pairwise differences between the artefacts size obtained at 1.5 T and 7 T and at 3 T versus 7 T. No significant difference in artefact size was found between 1.5 T and 3 T. The p-values of parameters changed in this investigation are listed in Table 5.

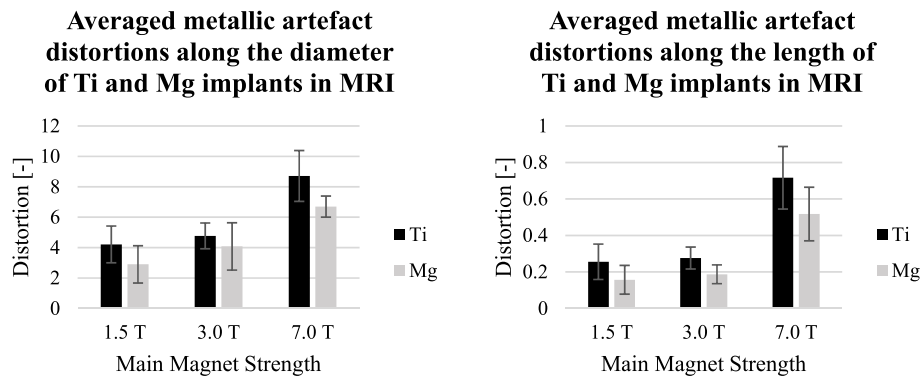
Fig. 4. Averaged artefact distortions of diameter (left) and length (right) measurements of Ti and Mg in MRI.

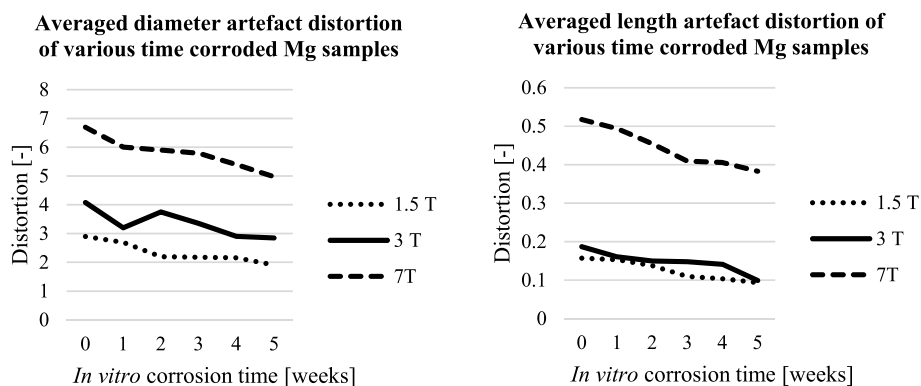
Fig. 5. Averaged diameter (left) and length (right) artefact distortions of Mg-based samples as a function of *in vitro* corrosion time.

Examining the effect of the Mg implant corrosion time on the artefact size revealed statistically significant results (Table 6). For all magnetic field strengths a general decrease of image distortion was found for increasing *in vitro* corrosion times of the implant (Fig. 5). The spin echo sequence produced lower artefacts than the gradient echo sequence (Fig. 6).

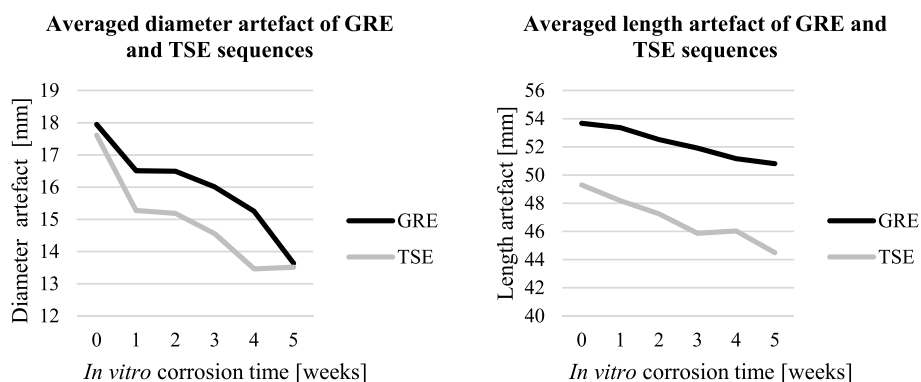
Fig. 6. Averaged diameter (left) and length (right) measured artefacts of Mg-based samples as a function of *in vitro* corrosion time and scanning sequences.

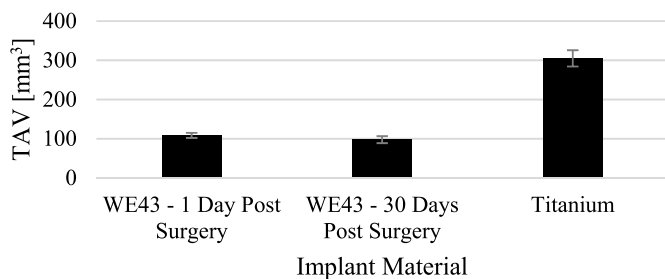
Total averaged metallic artefact volume (TAV) produced by Mg-based and Titanium pins in rat femurs (7 T Small Animal MRI)

Fig. 8. Total averaged artefact volume produced by pins implanted into rat femurs imaged in 7 T small animal MRI.

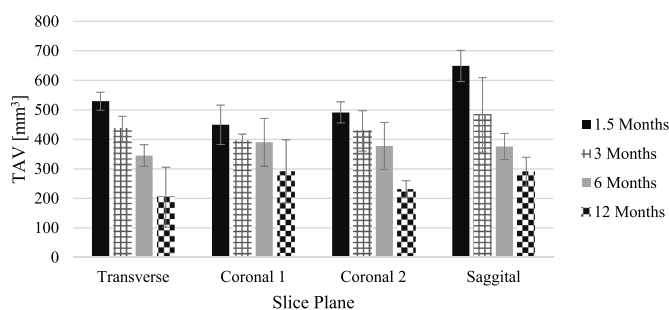
Total averaged metallic artefact volume (TAV) produced by Mg-based implant in 3 T MRI for the treatment of scaphoid fractures

Fig. 10. Total artefact volume produced by Mg-based implant as a function of healing time in different slice planes in 3 T MRI.

Fig. 9 shows a decrease in the hypointense area surrounding the implant after one month, three months, and twelve months post-surgery for a single patient. The rest of the patient data follows a comparable trend (Fig. 10). Significant differences were found between healing times and imaging slice positions. An increase in implant degradation and patient healing time resulted in a decrease in artefact production. Imaging the implant at 1.5 months with a T2w TSE sequence in the sagittal direction produced the largest TAV of approximately 650 mm³. Since the screw is implanted into the scaphoid bone, the shape of the implant in Fig. 9 is defined since it is primarily surrounded by one type of material, spongy bone.

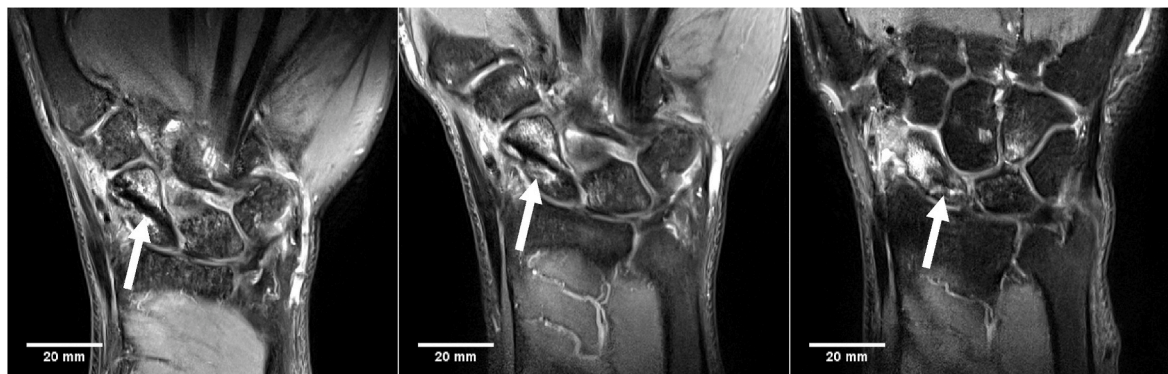
Fig. 9. T2-weighted images of scaphoid with Mg-based screw one (left), three months (middle), and twelve months (right) after surgery. White arrows indicate position of implant.
